SRB TECHNOLOGIES (CANADA) INC.

Subject: Final Written Report: November 4 Action Level Exceedance

FINAL WRITTEN REPORT

Action Level Exceedance – November 4, 2014

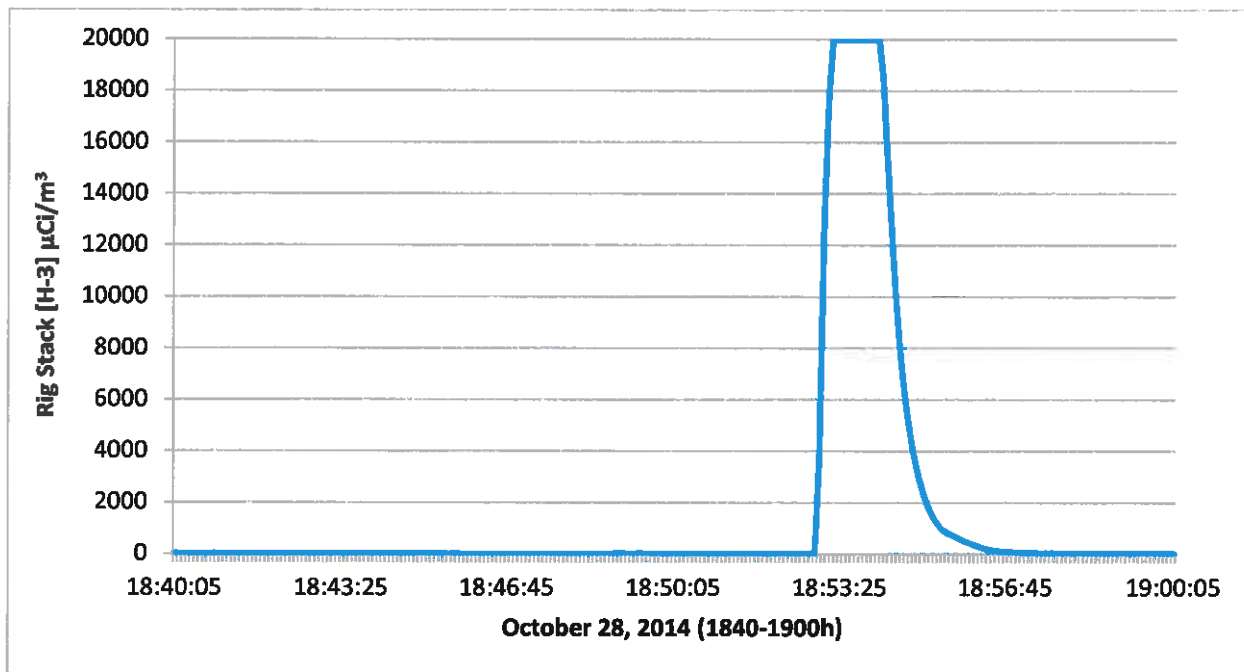
Figure 1 - Rig Stack Tritium Concentration Trend: Oct. 28, 2014 (1840-1900h)

A final attempt to determine specific leaking lights was undertaken by Zone 3 staff at 1852h; the plastic bag containing the suspect lights was opened. Figure 1 illustrates the tritium concentration that was observed on the real-time stack monitor at the time of opening the bags.

At this time, technicians focused on eliminating leakage to the active ventilation systems before the end of the workday at 1900h; the bags of GTLS were resealed and placed into two aluminum cans to provide an additional barrier to leakage. By 1856h, stack emissions had trended back down to normal levels, as can be seen on Figure 1.

Root Cause: Mishandling of a container of GTLS while attempting to isolate a single leaking unit, during the bagging and transfer of the container to Zone 3, and during the further attempts to isolate leakers in Zone 3, caused additional GTLS to develop leaks.

CA-1: All staff working in Zone 2 and 3 should be coached to ensure:

- That GTLS must be handled with care and caution at all times, including when attempting to isolate potential leaking sources.
- That when leaking lights occur and the source of the leakage cannot easily be determined in a batch of lights, careful heat-sealing in plastic is the preferred method to reduce or eliminate leakage outside of the 0700-1900h operating hours.

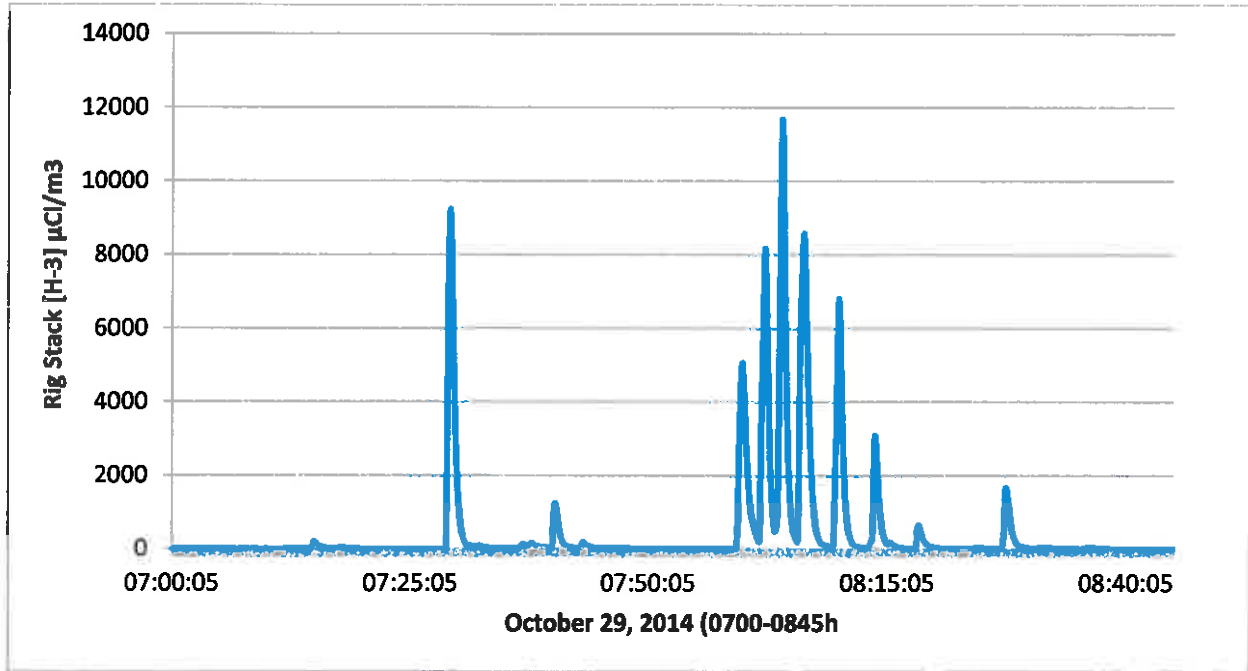
Figure 2 – Rig Stack Tritium Concentration Trend: Oct. 29, 2014 (0700-0845h)

Additional tritium gas was released through the gaseous effluent pathway when the cans were opened the next morning to assess the condition of the lights. This is shown on the graph of the Rig Stack releases between 0700h and 0845h on the morning of October 29 (see Figure 2), where distinct peaks of emissions occur as each can and bag of GTLS is opened under the ventilated fume hood.

The assessment of the condition of the GTLS on the morning of the 29th clearly showed that additional lights had developed leaks.

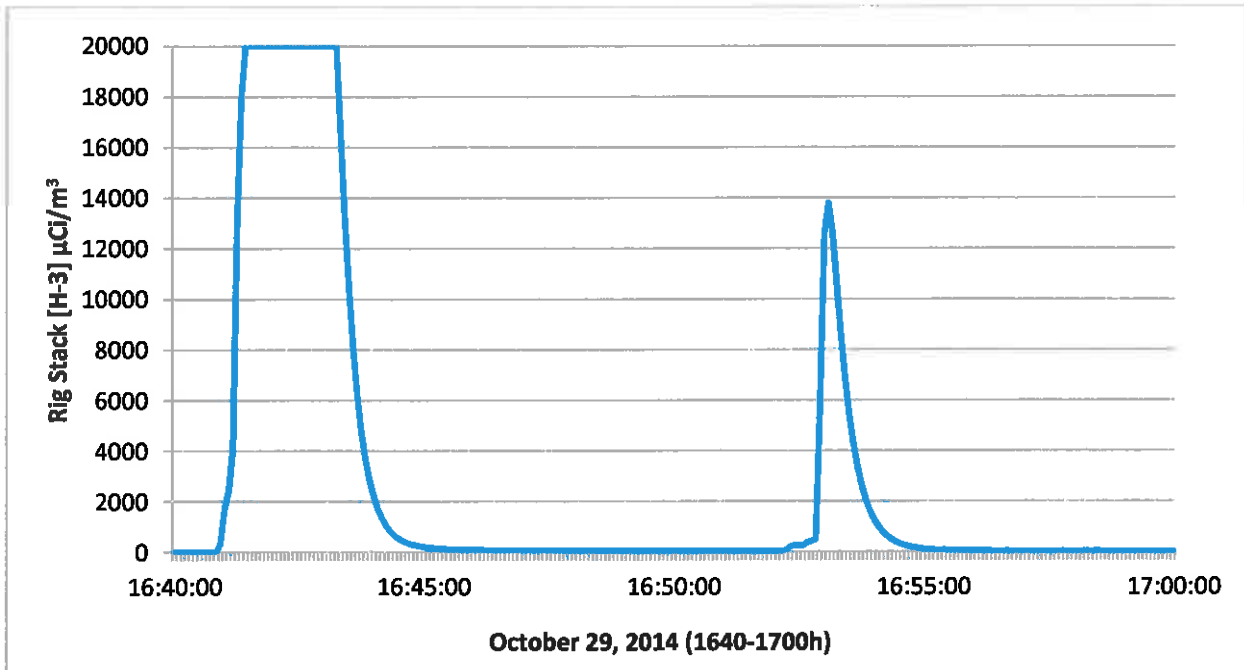
Figure 3 – Rig Stack Tritium Concentration Trend: Oct. 29, 2014 (1640-1700h)

Soon after, the system was ready to undergo purging. The vacuum pump was activated, and the vacuum isolation valve was opened. Nitrogen was admitted in a controlled manner in order to purge the system. At this point, abnormally high concentrations of tritium were measured by the real-time stack monitoring system. Purging was initially stopped, which paused the emission event; however, the transfer of tritium from the rig to the exhaust stream had already been completed. Purging continued in order to complete the processing operation as the tritium was no longer recoverable.

This sequence of events is corroborated by the data collected by the stack monitoring chart recorders. A graph of data from the digital recorder is included (see Figure 3):

The most likely cause of the tritium excursion is that the manifold gauge isolation valve leaked to atmosphere, causing air to enter into the line between the valve and the gauge. When the isolation valve was opened, this air then entered into the rig and interacted with the PUTT, liberating tritium that was subsequently rejected via the purging operation.

Once empty, calibration activities showed that the PUTT associated with this event exhibited evidence of a loss of tritium that correlates with the magnitude of the estimated release from this event (~8,000 - 10,000 GBq).

CA-2: The manifold gauge isolation valve on the Rig 7 purging system should be replaced, including the valve body.

CA-3: Operators should be coached to ensure that if it is noticed that the manifold gauge pressure indicator exceeds 100 mbar (as opposed to slowly rising during a filling run), this may be indicative of potential air ingress into the system. Supervision should be contacted for further instruction prior to opening the affected line onto the PUTT.

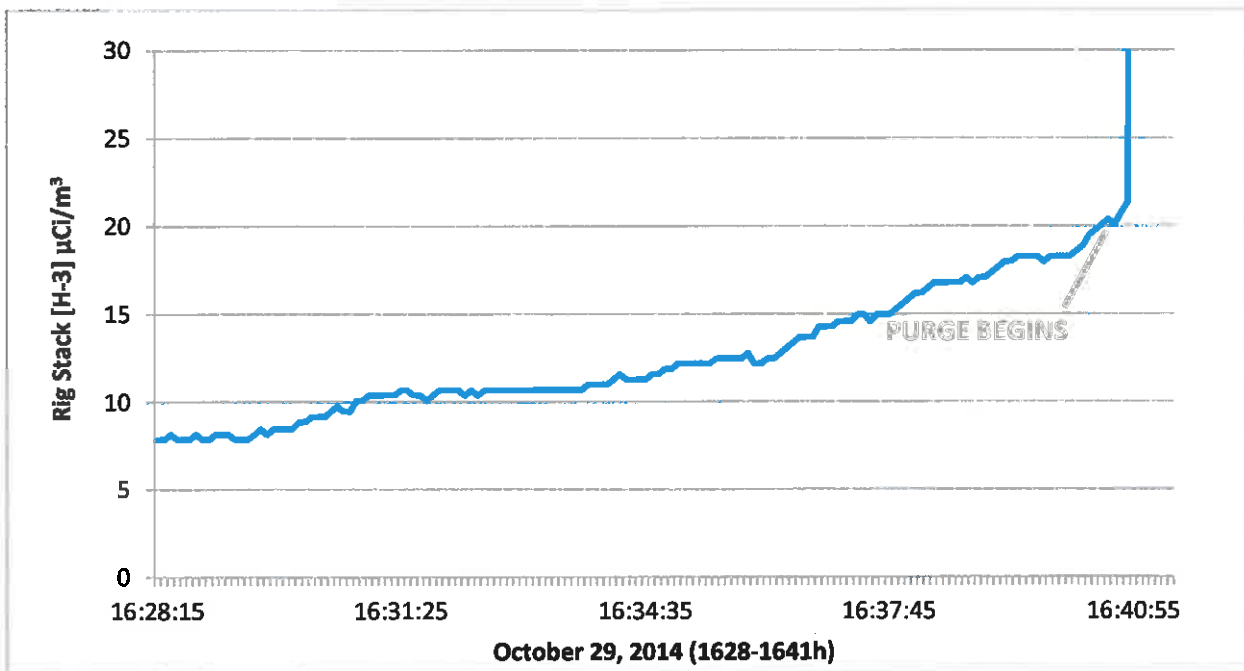
Figure 4 – Rig Stack Tritium Concentration Trend: Oct. 29, 2014 (1628-1640h)

If we look closely at the real-time stack monitoring data, a gradual rise can be observed prior to the purge cycle being started (see Figure 4). This would suggest that there was tritium being liberated from the system due to the air ingress; the purge then rapidly ejected this tritium through the pump exhaust.
